State of Illinois
ENVIRONMENTAL PROTECTION AGENCY
MEMORANDUM

DATE: August 2, 2011
TO: Division Files - Bureau of Land
FROM: Chris Cahnovsky – Collinsville Region *CC*
SUBJECT: 1198010003 – Madison County
Estate of Chemetco
FOS File

FOUNDRY BUILDING DEMOLITION

1198010003 — Madison County
Hartford/Chemetco
FOS File

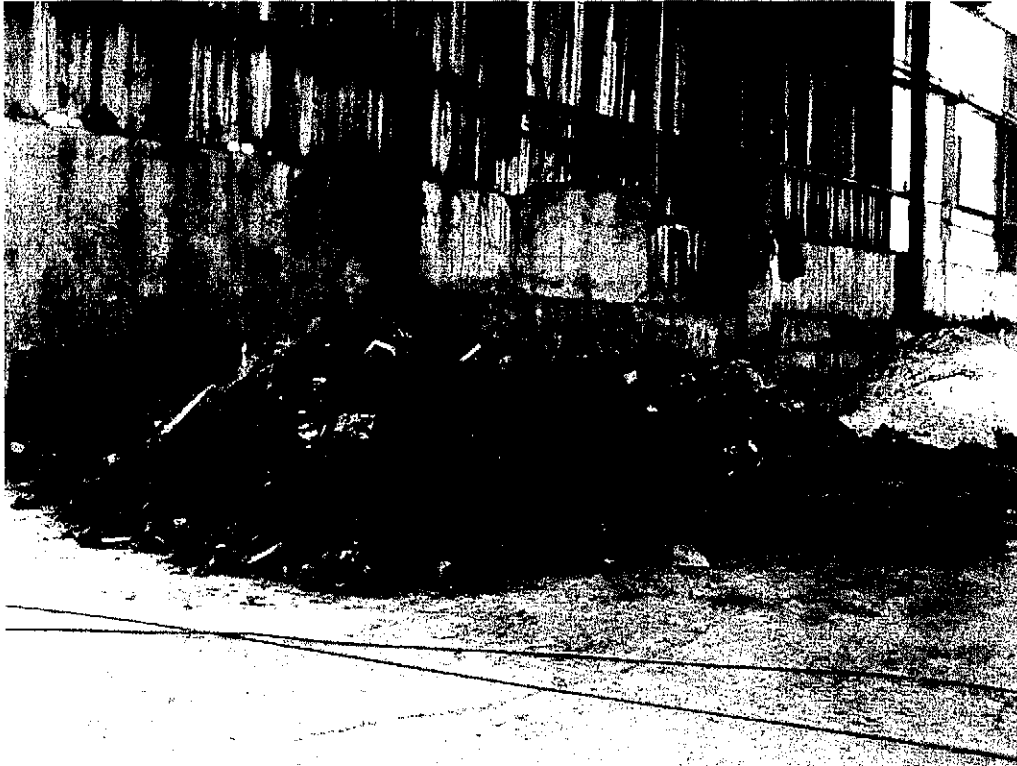
On July 22, 2011, Mr. Garcia escorted me through the Foundry Building including the office area at the northeast end of the building. AIS has been on-site cleaning the floor of the Foundry Building and removing furniture and other material from the offices. AIS was not on site during this inspection. I observed the work AIS has been doing under the furnaces and the on the foundry floor. The areas under the furnaces have been cleaned up. The furnace cleanup solids have been consolidated with other solids on the foundry floor along the west wall of the foundry. I observed several new piles of foundry cleanup solids along the west wall. This material appeared to contain a large amount of copper.

Date: 7/22/2011
Time: 10:50 – 11:30
Direction: Northwest
Photo by: Chris
Cahnovsky
Exposure #: 001
Comments: Material
removed from
around the furnace

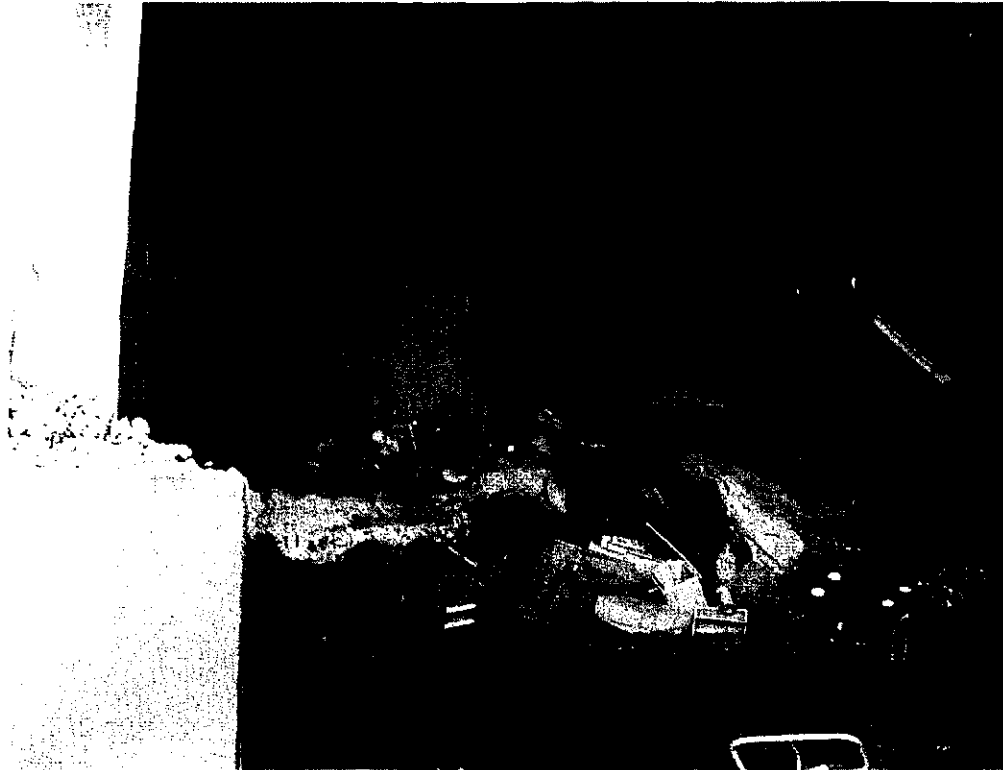
AIS has begun to clean out the foundry office in preparation for the asbestos abatement. Three outside walls of the office have been opened to allow AIS personnel to remove furniture and other items through the openings. The largest opening is on the north side of the foundry. Under this opening was a RCRA roll-off containing office furniture and other debris contaminated with lead and cadmium dust. This bin was open and not labeled with the words "Hazardous Waste".

Date: 7/22/2011
Time: 10:50 – 11:30
Direction: Southeast
Photo by: Chris
Cahnovsky
Exposure #: 009
Comments: Open
wall to access office
spaces and office
equipment

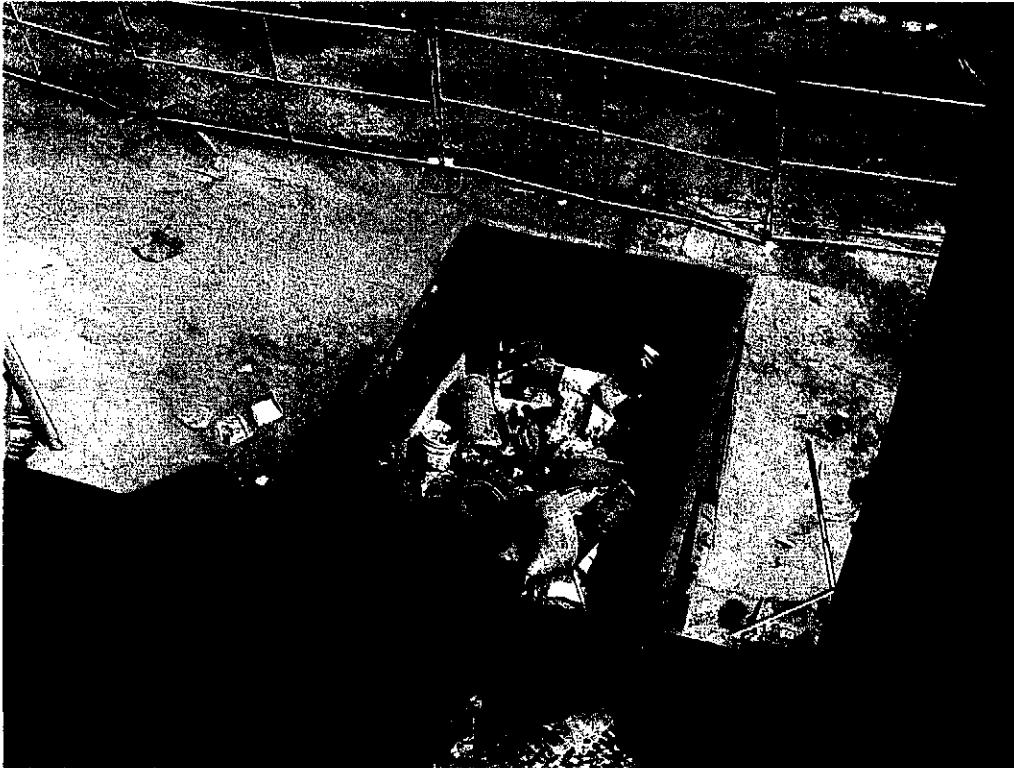
Date: 7/22/2011
Time: 10:50 – 11:30
Direction: North
Photo by: Chris
Cahnovsky
Exposure #: 011
Comments: RCRA
waste from second
floor offices. Note
that box is open

I again observed the RCRA roll-off box. This box was open and not labeled with the words Hazardous Waste. I instructed Mr. Murray to label the box and keep it closed when waste was not being added or removed from the box. He agreed to label and close the box. No further work has been conducted in the office. Mr. Murray is waiting for the asbestos contractors to begin removing and cleaning up the broken transite panels that were discovered when the south wall was opened. Per Mr. Murray, the original asbestos inspection did not identify this wall as having asbestos paneling.

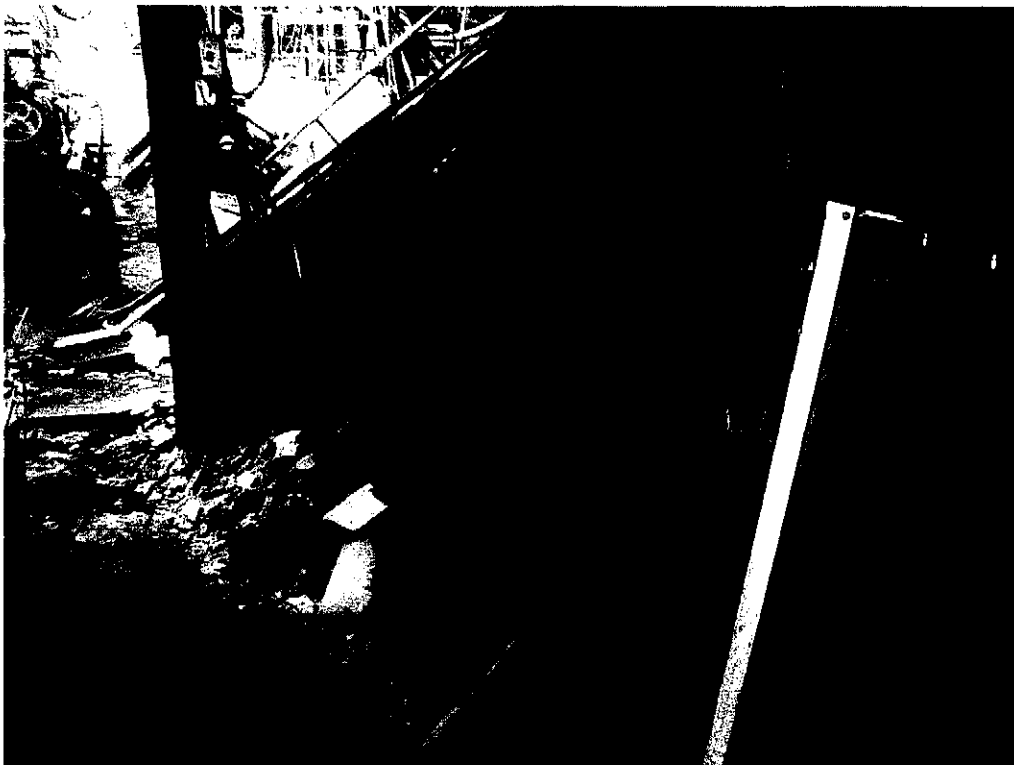
An opening was made in the south wall to allow AIS to access the furnace deck. This wall was constructed of transite panels. The transite panels were damaged when the wall was opened. Asbestos containing waste material (ACFM) was observed on the floor of this room. A second transite wall was damaged in a room along the west wall.

Date: 7/22/2011
Time: 10:50 – 11:30
Direction: South
Photo by: Chris
Cahnovsky
Exposure #: 012
Comments: broken
transite panel
